# Colonial Parkway Reconstruction

## Mega-Project\* Profile: COLO Parkway Reconstruction

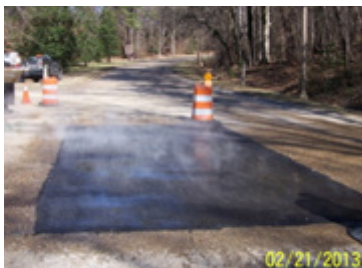
**Above:** Asphalt patches checkerboard the Parkway.

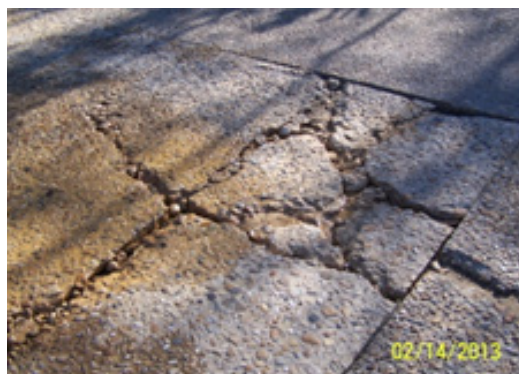
**Middle bottom:** Typical failed slab in high bus traffic area. Joint failure and slab cracking lead to water infiltration, pumping, and ultimate failure.

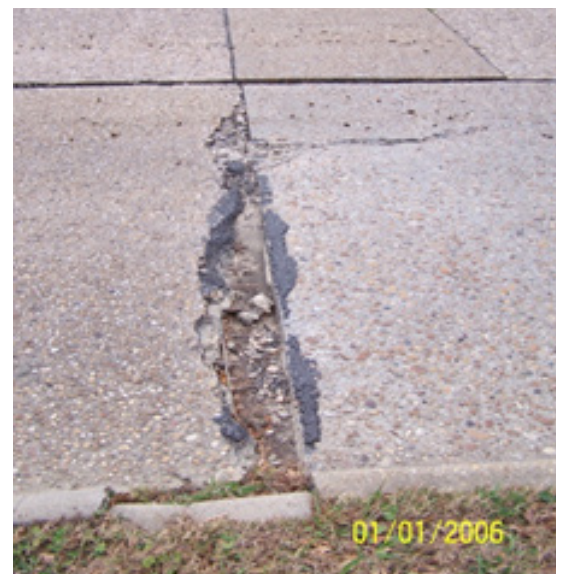
**Right middle:** Edge failure, patch failure, curb failure, joint sealant failure, cracked slab, slab settlement. High bus traffic area.
